## SWD WATER TREATMENT AND H<sub>2</sub>S CONTROL USING A RENEWIQ™ SOLUTION

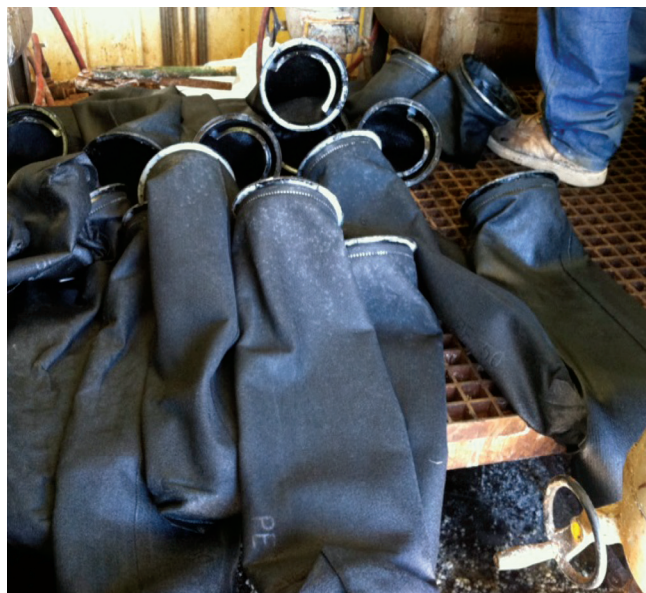
Figure 1 - Fouled sock filters prior to injection of BIOC16734A.

The local Nalco Champion sales group saw an opportunity to resolve all of the production issues by applying a RenewIQ™ solution that utilized BIOC16734A biocide and requested permission to conduct a trial. The operator approved the trial and work commenced. The trial consisted of monitoring changes in the levels of H<sub>2</sub>S in both the aqueous and gas phases, bacteria, and water clarity. Water clarity was determined by comparing turbidity, frequency of sock filter changes, and volume of throughput using a Millipore filter.

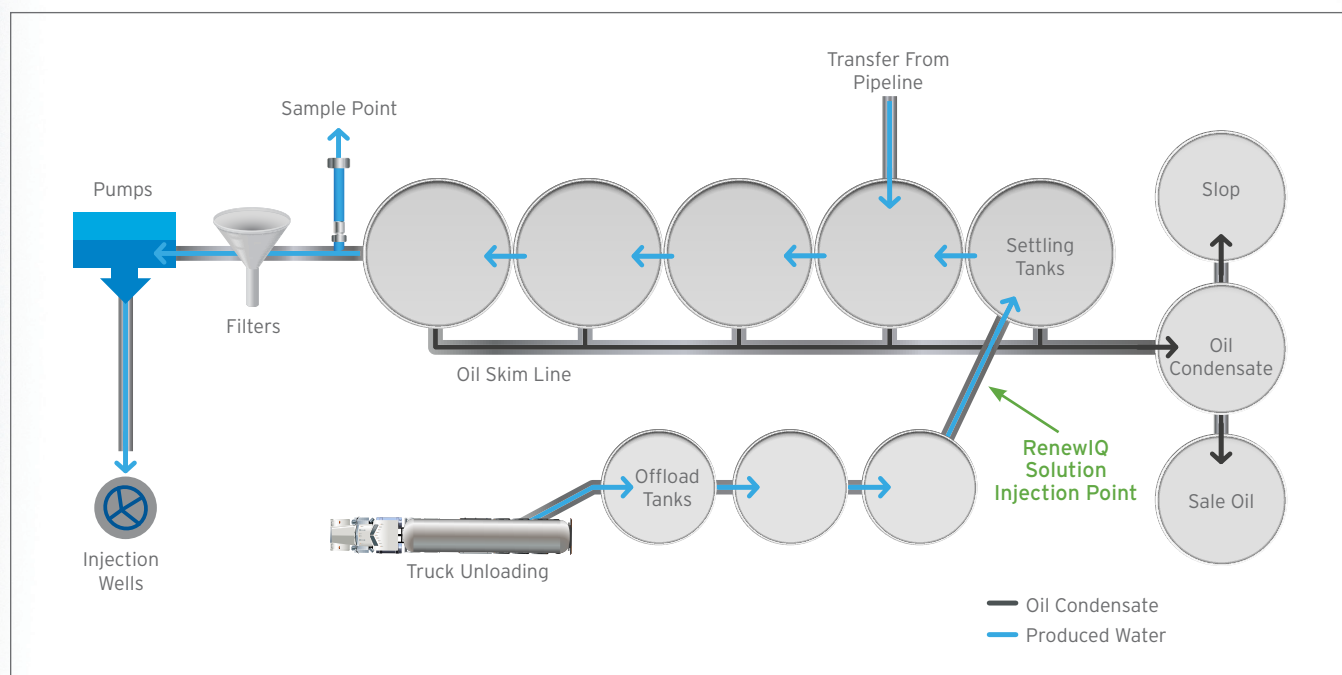
Figure 2 - Layout of the SWD facility. Trucks deliver water daily into the offload tanks and the pipeline flow is delivered into the settling tanks sporadically. Samples were taken from the sample point to determine the effects of BIOC16734A biocide.

Trucks brought a consistent daily volume of water, while the pipeline flow was irregular. Water from the two sources entered at different locations in the facility and were allowed some settling time through a series of large tanks. The water then flowed through sock filters and was pumped into the injection wells.

While in the settling tanks, the produced water continued to separate, allowing oil to be skimmed off the top and sold by the facility.

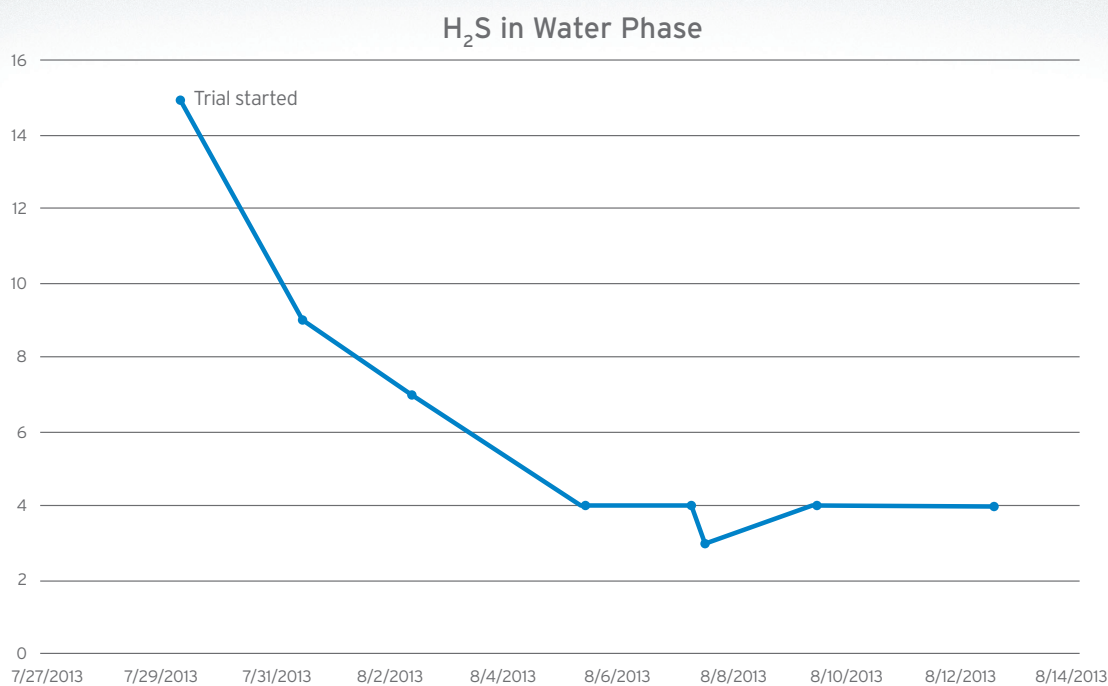
Figure 3 - The figure above shows that BIOC16734A biocide reduced the dissolved H<sub>2</sub>S in the water phase from 15 ppm to a consistent level of 4 ppm. In addition, H<sub>2</sub>S in the gas phase was decreased from as much as 200 ppm to 0 ppm.

All key performance indicators that were monitored showed improvement with the new treatment. Specifically,  $H_2S$  levels were reduced in both the water and gas phases (see Figure 3), bacteria levels were reduced, and water quality was improved (see Figure 4).

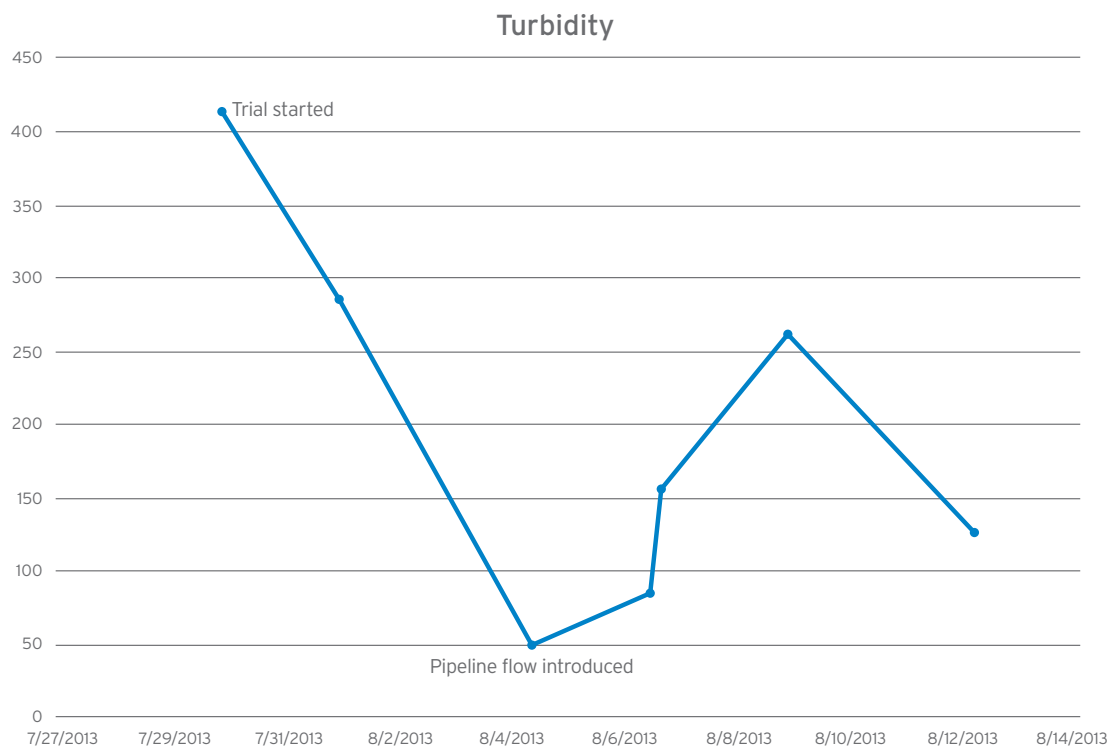
Figure 4 - The figure above shows the effect of BIOC16734A biocide on water quality at the sample point. Initially, turbidity was reduced. The introduction of untreated pipeline water created a temporary spike in turbidity. After adjusting the RenewIQ solution treatment, water turbidity was again reduced. BIOC16734A biocide addition also helped extend the frequency between sock filter change outs, which were previously changed daily due to excessive system fouling, to once every 6 days after implementation of the RenewIQ solution.
