3D TRASAR™ Water Saver Technology helps a global automobile manufacturer exceed water saving goals and ensure optimum cooling system performance

CASE STUDY - MANUFACTURING

CH-1534

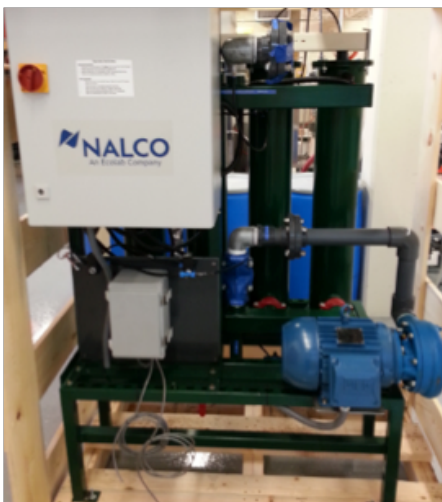
Figure 1

3D TRASAR Water Saver technology is an electrochemical precipitation technology that preferentially removes hardness minerals from cooling water. By removing these minerals from the water, blowdown is reduced and cycles of concentration are increased resulting in significant water savings.

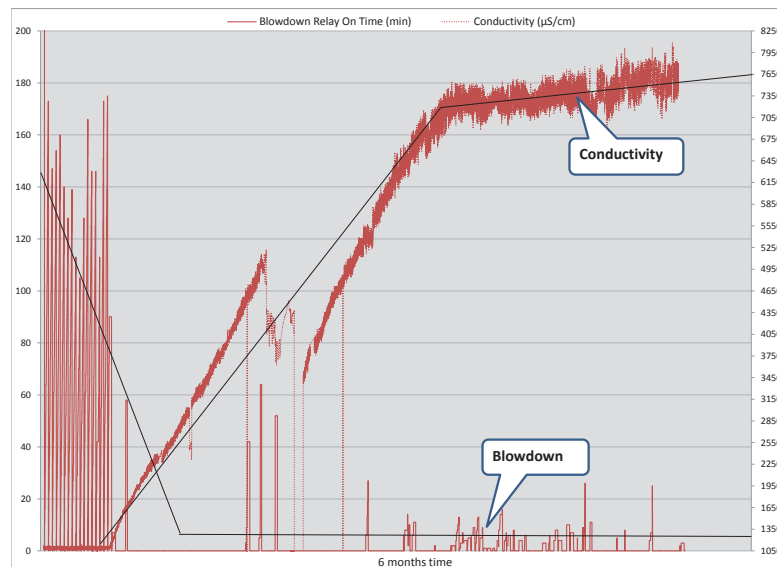
Figure 2 - Cooling System Blowdown and Conductivity

Conductivity went from approximately 1050 umhos to 7350 umhos which equated to 40+ cycles of concentration. Blowdown was reduced by 87% resulting in significant water savings. See Figure 2.

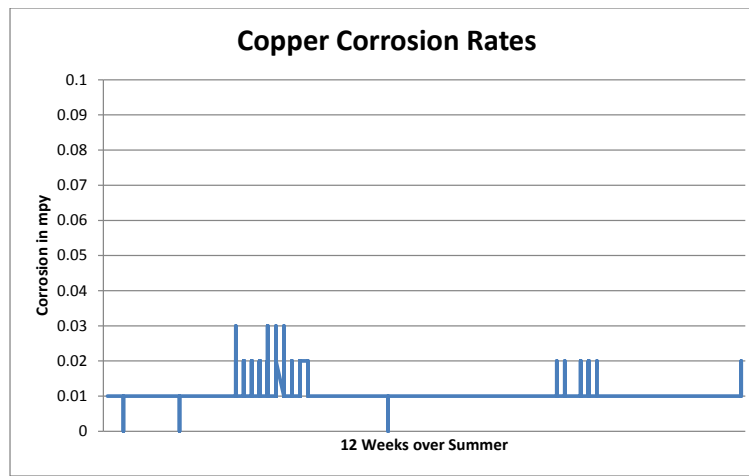
Figure 3 - Cooling System Corrosion Rates

Corrosion Rates were maintained at 1.5 mpy for mild steel and < 0.05 mpy for copper through the hottest part of the summer. These are well below the recognized industry standards for corrosion in cooling water systems of <3.0 mpy for mild steel and <0.3 mpy for copper. See Figure 3.
