OMNI Heat Exchanger Reliability Provides Unique Insight into Cooling Water Treatment and Heat Exchanger Performance

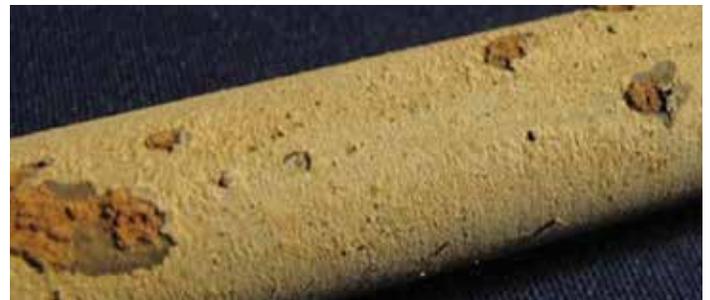
figure 1

Photomicroscopy and deposit analysis conducted on both exchangers showed a buildup of mineral scale (Figure 1), primarily composed of iron phosphate, which resulted in under-deposit corrosion (Figure 2).3

Exchanger 1: Velocity: 4.0-4.5 fps; Skin Temperature: 115 °F

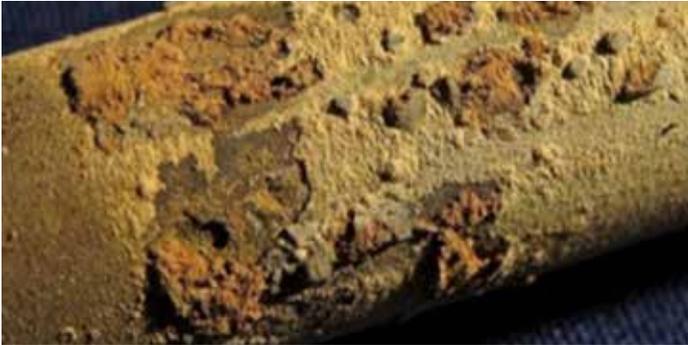
figure 3

A thicker layer of iron phosphate scale (Figure 3) was found on Exchanger 2 that operated 10 °F higher skin temperature. The scale surface is interrupted by iron tubercles which, once removed, revealed deep pits (Figure 4).

Exchanger 2: Velocity: 4.0-4.5 fps; Skin Temperature: 125 °F
