3D TRASAR™ Technology for Dilution Steam Systems Reveals Significant Swings in Quench Tower Process pH

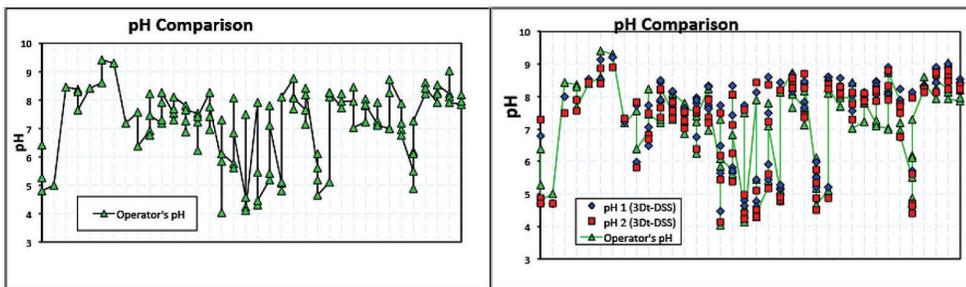
FIGURE 1: BASELINE pH - READINGS REPRESENT THE PH OF BOTH DEVICES DURING THE SAME TIMESTAMP

After calibrating the handheld and surveying twice a shift for six weeks, the results were plotted against the 3DT-DSS pH, shown in figure 1.

The 3D TRASAR unit was not only very accurate against the handheld, it delivered results greater than 90% success criteria.

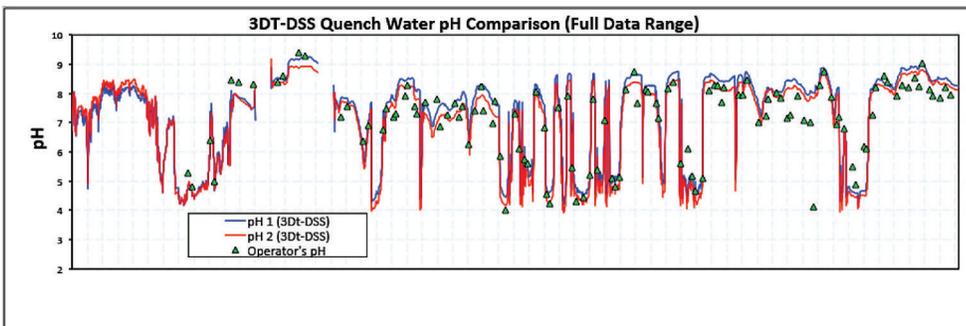
FIGURE 2: FULL pH DATASET PLOTTED WITH REAL-TIME 3DT-DSS RESULTS WITH MULTIPLE PH SWINGS

Further analysis was performed to understand what data the online measurement captured that the manual method might have missed (Figure 2).

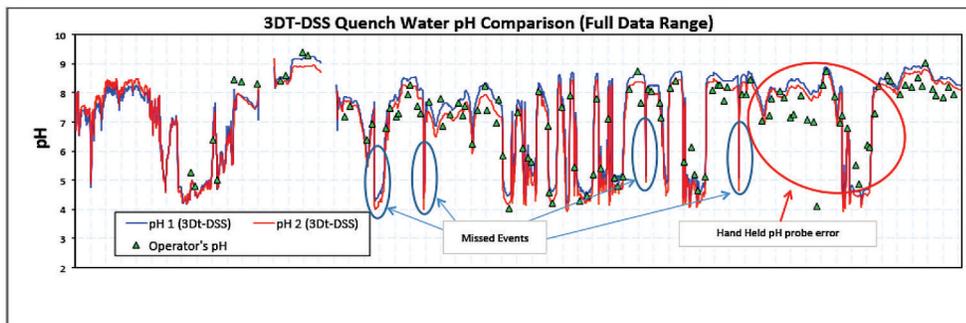
FIGURE 3: SIGNIFICANT pH EVENTS MISSED BY HANDHELD AND FAILED EQUIPMENT

Looking at the full online 3DT-DSS results, there were multiple periods where the pH dipped in between measurements which would have gone unnoticed had it not been for the 3D TRASAR unit. Figure 3 not only highlights these missed pH excursions, but also identified bias error in the handheld itself. This bias was discovered by the 3DT-DSS system because of the units redundant probes. Only after seeing both TRASAR pH readings consistently tracking similar values and the handheld readings diverging from the TRASAR's output(s), was the hand-held was recalibrated.

These pH excursions expose the unit to potential emulsions, foaming, corrosion, and accelerated fouling. After reviewing with operations personnel, it was identified that the error in the hand-held was due to contamination in the probe. Again, this would not have been captured without the dual pH probes to validate the problem and launch an investigation into the error.
