Gulf Coast Natural Gas Liquid (NGL) Plant Uses PURATE™ Chlorine Dioxide Technology to Avoid \$2 Million in Production Losses and Operating Costs

BACKGROUND

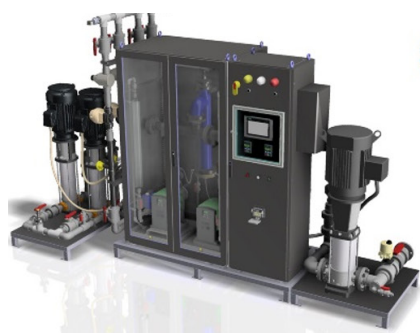
FIGURE 4: The PURATE Process

Sodium Chlorate + Hydrogen Peroxide

PURATE + Sulfuric Acid → Chlorine Dioxide + Oxygen + Sodium Sulfate + Water

PURATE generates chlorine dioxide using a two-component process. As shown in Figure 4, the PURATE product, a blend of sodium chlorate (NaClO₃) and hydrogen peroxide (H₂O₂), reacts in the PURATE generator with sulfuric acid (H₂SO₄) producing, as shown in Figure 5, chlorine dioxide (ClO₂), oxygen, sodium sulfate (Na₂SO₄) and water.

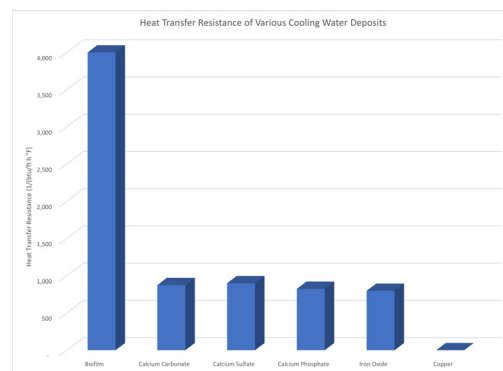
Figure 6: Comparison of the heat transfer resistance of various cooling water deposits. Microbial slime is 4.5X more insulating than mineral scale.

Growth of a large sessile population impacts a cooling system by insulating heat transfer surfaces. Microbial slime is 4.5 times more insulating than mineral scale, as shown in Figure 6. The slime forms as

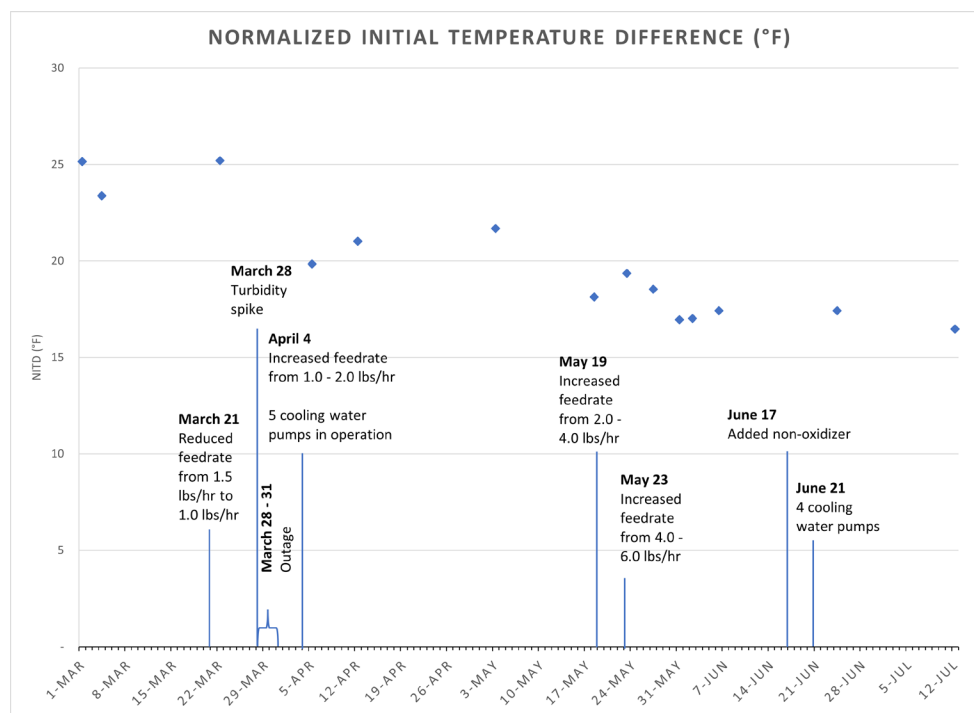
Figure 5: A declining Normalized Initial Temperature Difference (NITD) trend indicates an improvement in condenser efficiency and heat transfer

As shown in Figure 5, an effort was made in mid-March to optimize the chlorine dioxide dosage and assess the impact of chlorine dioxide on the yellow metal corrosion inhibitor in the system, generator production was decreased from 1.5 lbs/hr to 1.0 lbs/hr.² NITD was relatively high at this time and algae growth was noted, but operational data, including microbial testing, indicated normal conditions. No impact was measured on the yellow metal corrosion inhibitor.

that day. When brought back online, the chlorine dioxide application rate was increased again to 2.0 lbs/hour to address the algae concerns and an additional cooling water pump was put in service to increase cooling water flow and bring down the NITD. On May 19, the dosage was increased to 4.0 lbs/hour and, on May 23 to 6.0 lbs/hr. Prior to this change, algae growth was brought under control, but the NITD remained high. On June 17, a non-oxidizing biocide was added to further penetrate and remove any biofilm accumulated in the system. Within a few days, the additional cooling water circulating pump was taken offline and, following an additional non-oxidizer application on July 7, NITD had returned to its target. System efficiency and production rates were restored and asset damage from MIC prevented.
